NAS CR-120865
WANL-M-FR-72-012
DECEMBER 1972

METALLURGICAL EVALUATION OF FACTORS INFLUENCING THE DUCTILITY OF AGED T-111

WESTINGHOUSE ASTRONUCLEAR LABORATORY

CONTRACT NAS 3-15560

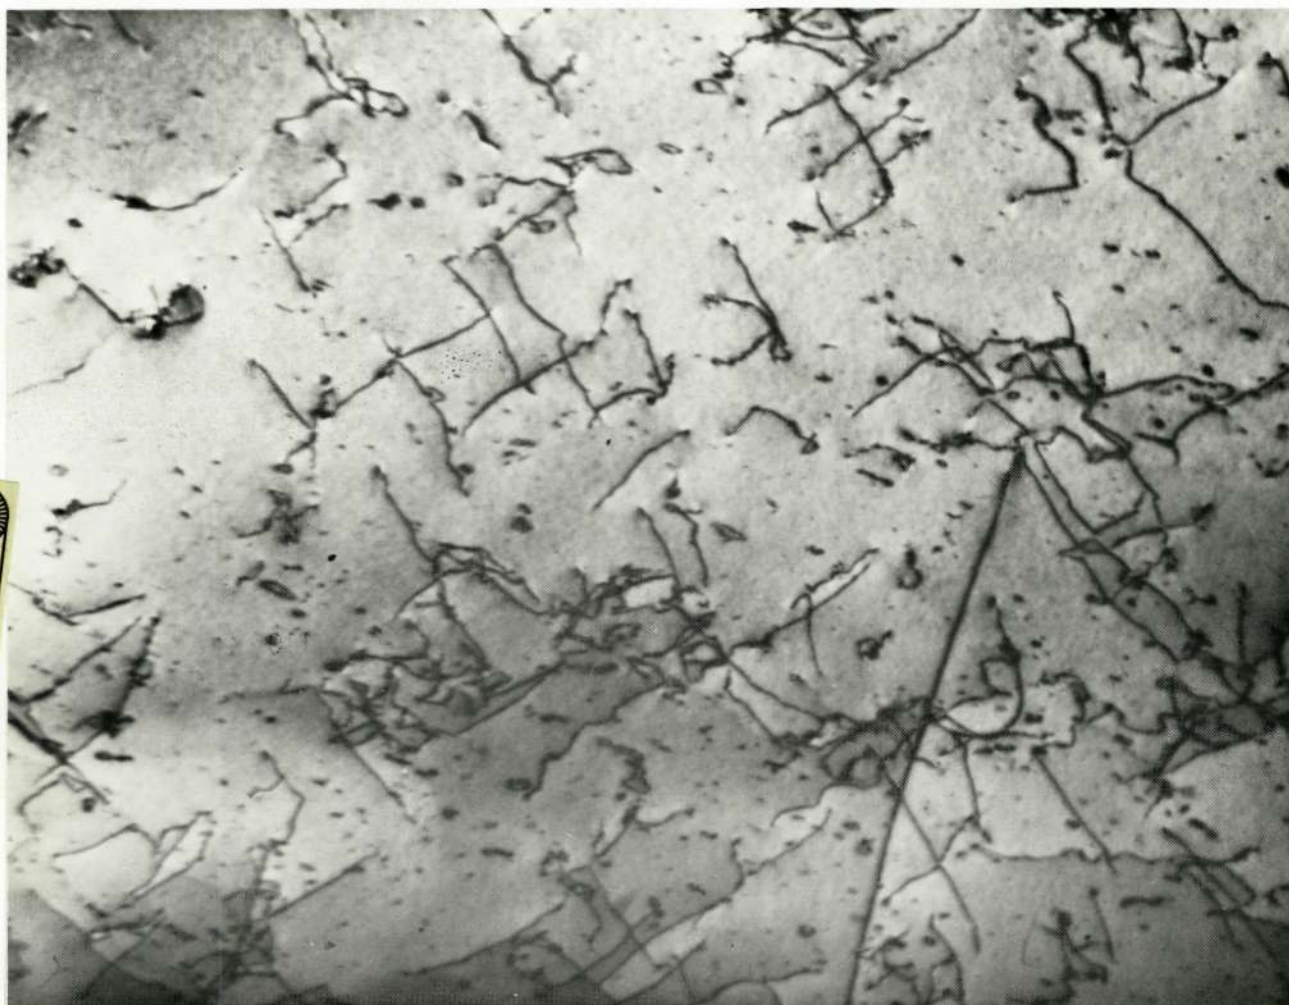
FIGURE 21. Transmission Electron Micrograph of GTA Weld Specimen 6.

The dislocation density was generally low with some evidence of cross-slip and dipole formation, Figure 21. Typically, evidence of precipitation was scarce except for oxide particles at the grain boundaries.

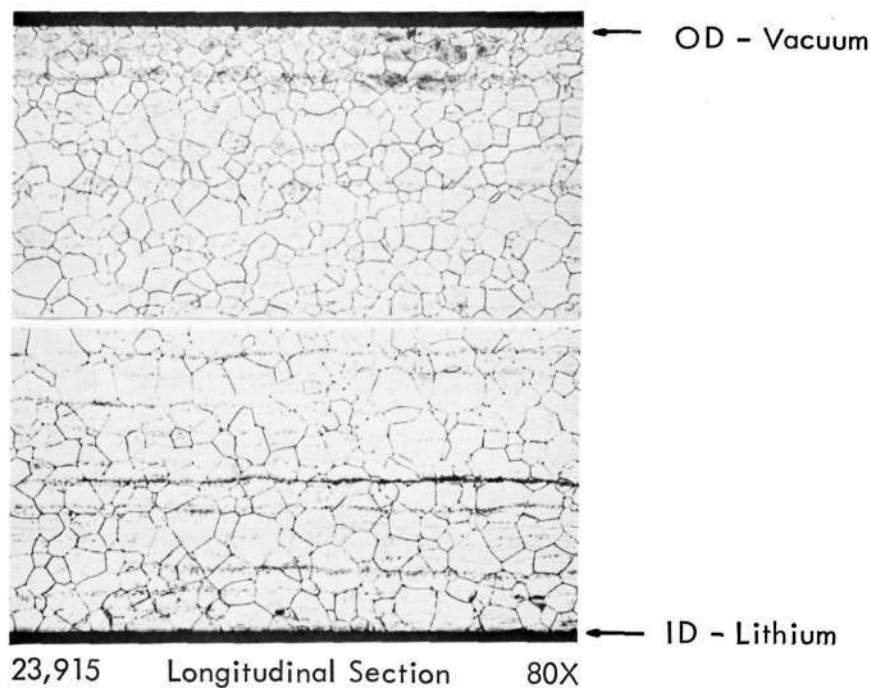
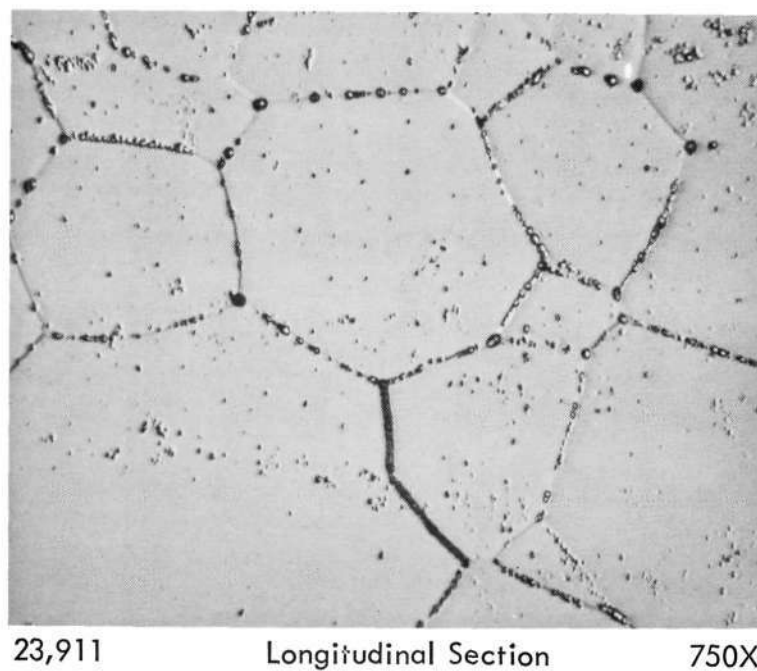
FIGURE 34. As-Aged Microstructure of T-111 Tube Specimen 11.

Specimen 11. The microstructure of this material, aged for 7500 hours at 1038°C (1900°F) is shown in Figure 34. Experience with T-111 has established that the grain boundary precipitate observed is almost certainly HfO_2 . The plentiful occurrence of this precipitate implies a much higher oxygen content than normal for this alloy.

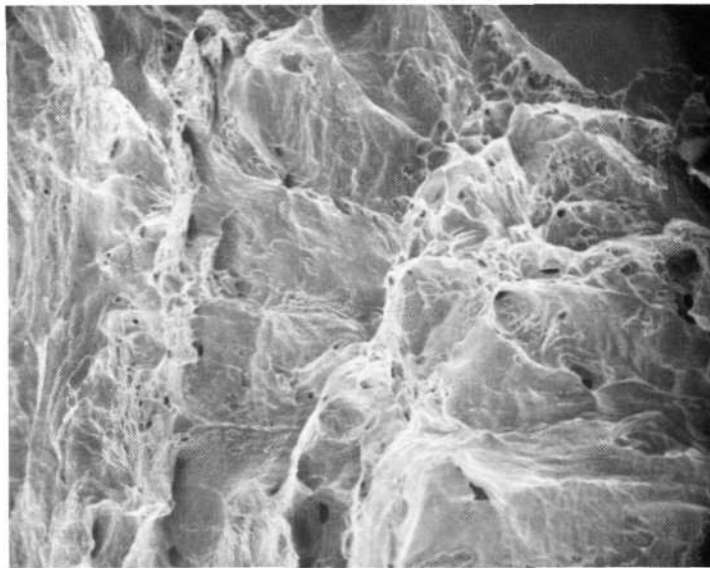
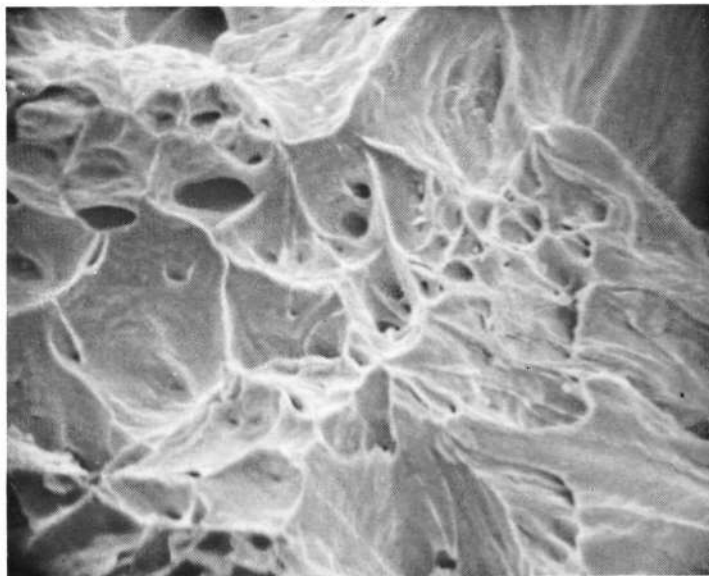
FIGURE 36. Scanning Electron Micrographs of Fracture Surface of T-111 Tube Specimen 11 ; Fractured in Auger Apparatus at -150°C (-238°F). Annealed 1 Hour- 982°C (1800°F) Prior to Testing.

These results imply the notch-machining operation has a tremendous influence on the fracture behavior of this material. There have been other similar observations of the critical nature of the pre-test specimen preparation procedure and while the exact mechanism is not known the possibility of a hydrogen-like embrittlement effect is indicated.

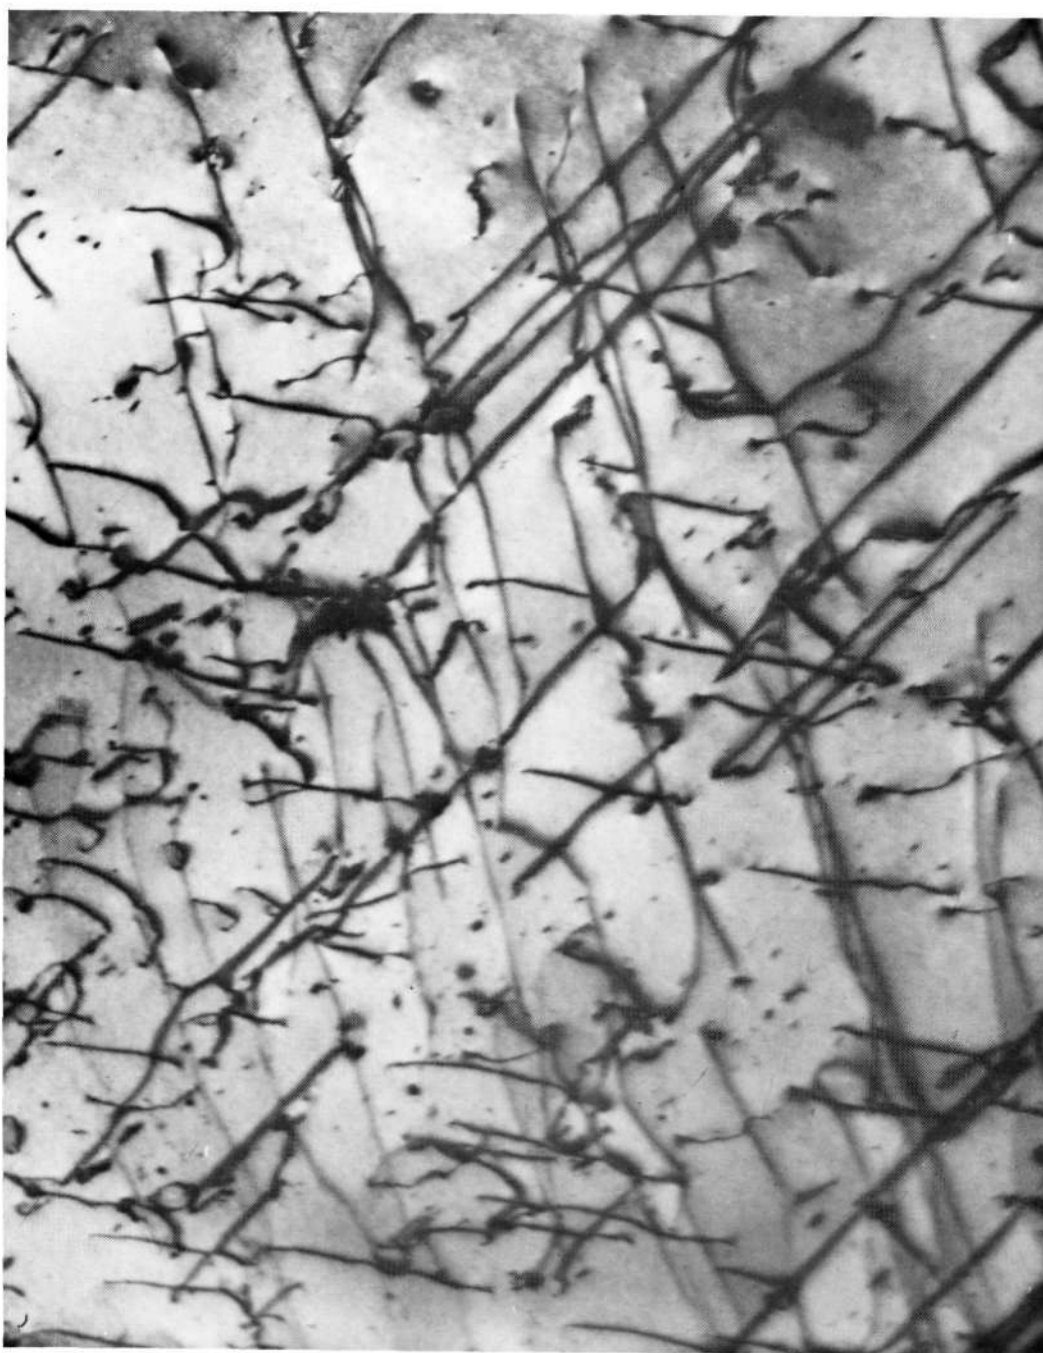
Figure 38 is a transmission electron micrograph of a region near the fracture of the bend-fractured specimen. The structure shown is fairly typical of this material. Dislocation segments display a tendency to lie along preferred directions. Dipoles and some evidence of cross-slip can be seen.
